Bridge Department
California Division of Highways
Sacramento, CA 95807

CAPACITY
OF
PILE ANCHORS

Final Report

December 1972

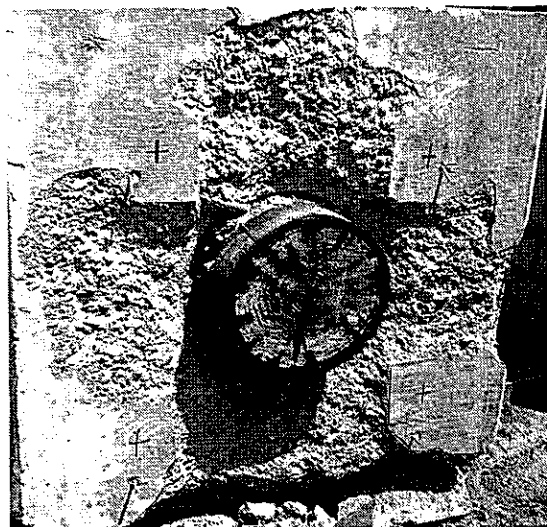
Figure A-4

Typical Cracking Patterns in
Loaded End of Test Specimens
(Cracks Have Been Marked with
a Marking Pen for Clarity)

This type of failure was also typical for each anchor tested except anchor No. 5. Photographs of several pile anchor specimens that were loaded to failure are shown in Figure A-4.
